# Manhole Inspection Summary

Manhole # S01UU1010MH

Insp Date: **8/1/06 8:16 AM**

**Location** Address: **3711 MENLO DR**

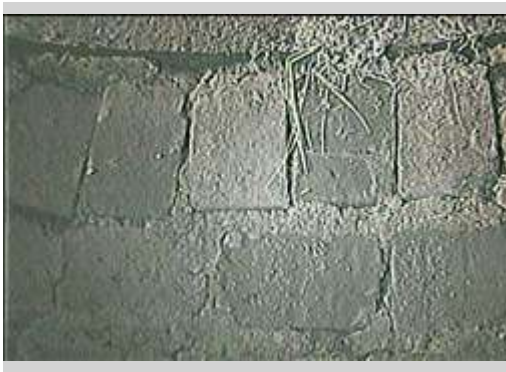
Defect

Infiltration: ☐ None ☒ **Joint** ☐ Cracks ☐ Mortar ☐ Roots ☐ Wall

infiltration at rim

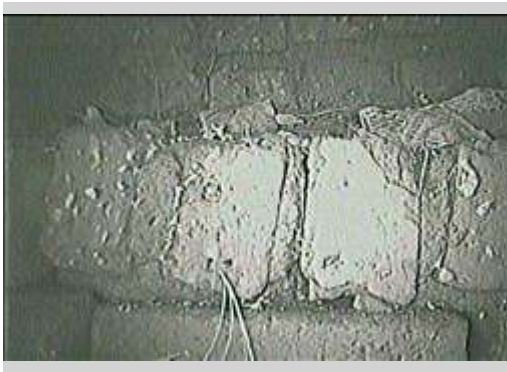
Defect

Condition: ☐ Sound ☐ Cracked ☐ Root Intrusion ☒ **Deteriorated** ☐ Leaks ☐ Debris

bench/channel deterioration

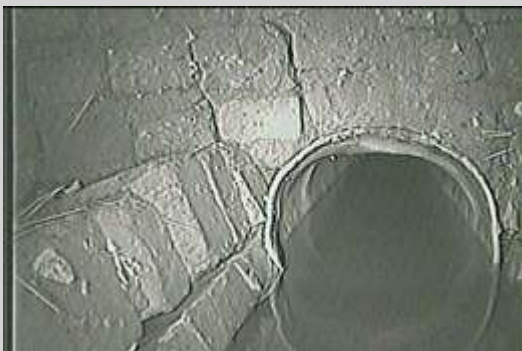
### 8 in. Circular Gravity Sewer Pipe In @ 6 O'Clock

bench damaged - pipe lined
